WATER QUALITY MEMORANDUM

Utah Coal Regulatory Program

RE: 2008 Third Quarter Water Monitoring, West Ridge Resources, West Ridge Mine,
Task ID #3136

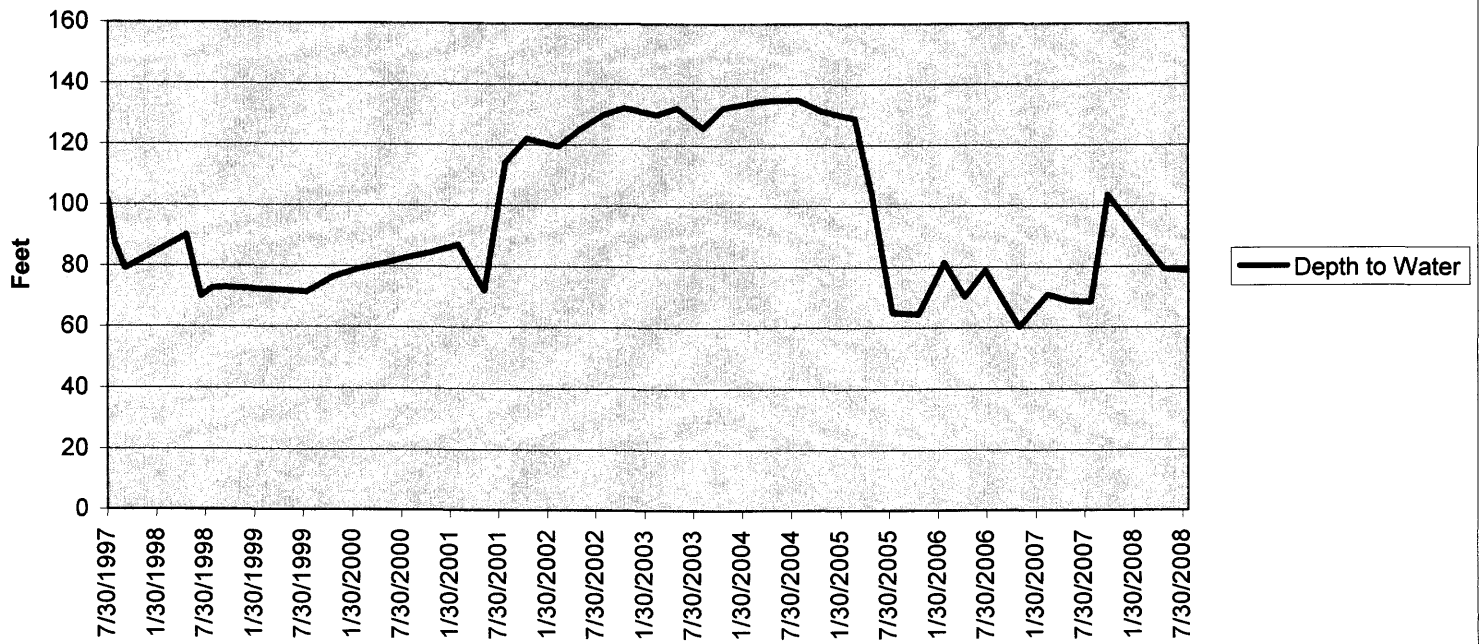
Well DH 86-2

Monitoring well DH 86-2 was sampled during this quarter and all required data submitted.

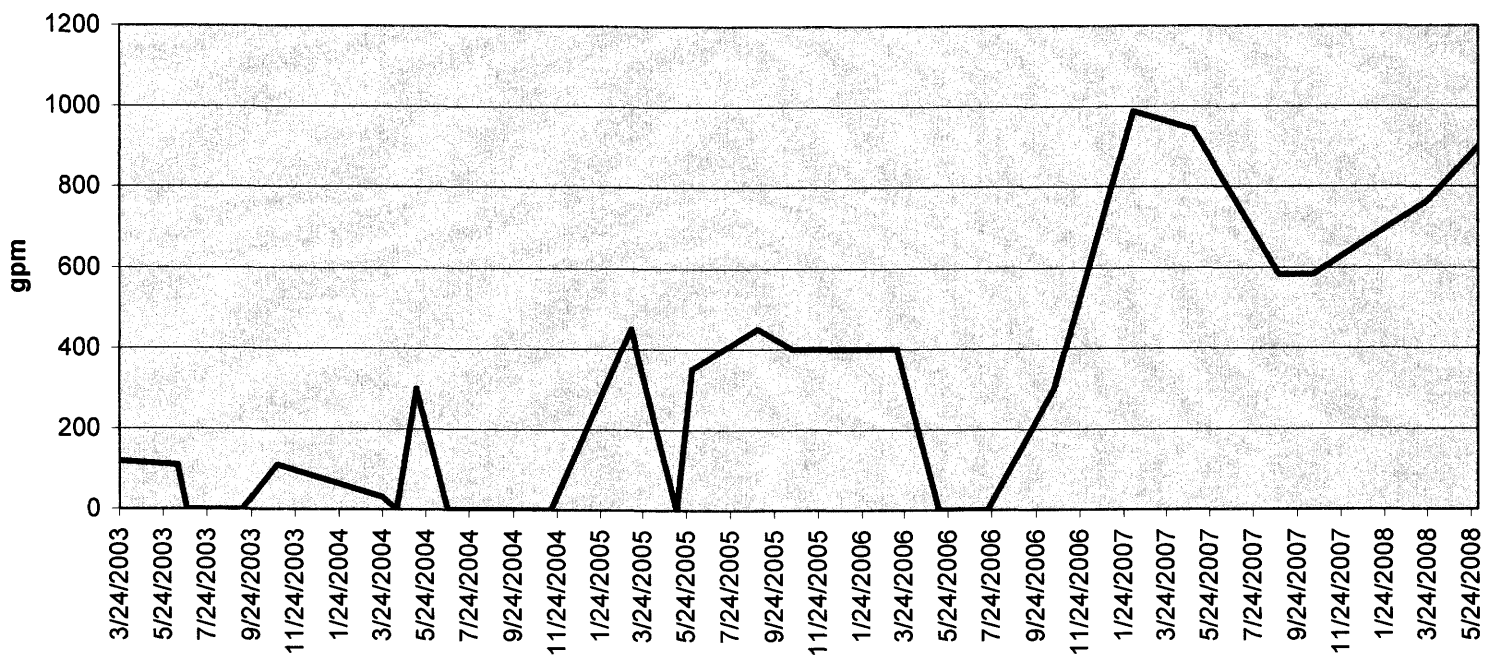
ST-5: Flow Values

ST-5- During the previous two quarters (WQ08-1 and WQ08-2), flow values were reported outside of two standard deviations (762.96 ppm and 897.6 gpm respectively). The reported flow value for this quarter is 3.5 gpm. Mine-water discharge is the primary source of water at this monitoring point. As a result of changing conditions underground in the mine works, the flow trends at this monitoring point have been erratic over time.

The previous two quarters, elevated flow values had been reported for site ST-5: 763.96 gpm and 879.6 gpm for the 1st and 2nd quarters of 2008 respectively. A flow value of 3.5 gpm was recorded for this quarter. This dramatic drop in flow is most likely attributable to changes in how the encountered mine-water is being routed within the mine. Erratic flow values have been historically reported at this monitoring site due to changes in encountered flow conditions in the underground workings.
